# CORROSERV (M) SDN BHD

CASE HISTORY ~ CH0033

## REHABILITATION OF FLANGES ON VESSELS

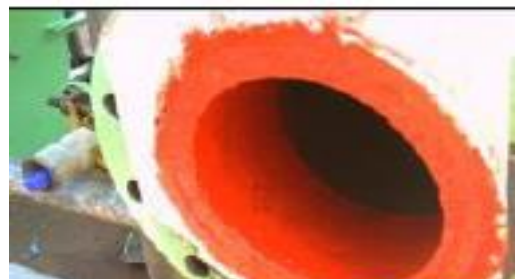
**THE CHALLENGE:** Currently, client has come across some heavy pitting on the raised face flange of their pipeline joints between 2 – 4 mm maximum during inspection on a routine shutdown. The client is looking for an alternative repair system that can rebuild the corroded part of the flange face and stop further deterioration or corrosion which if not attended to could induce leaks or would have to be replaced.

Figure 1: Application of Gas-Pruf 130 as primer
