CASE HISTORY ~ CH0104

LEAK SEALING & REHABILITATION OF 24" VENT GAS WASH TOWER

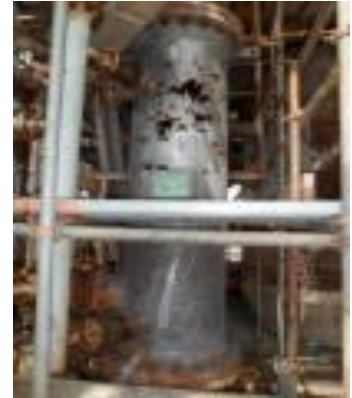
THE CHALLENGE: The client's vent gas wash tower vessel, C-0701 is leaking due to external corrosion. There are five nozzles at the unit, 3 at the upper half and 2 at the lower half of the vessel. Holes between 25 – 50 mm are scattered at the defect area. While waiting for a new unit to be fabricated as the vessel replacement, the operation department needs the damaged vessel to be repaired. So, the client requested Corroserv (M) Sdn Bhd to seal the defect area and rehabilitate the vessel.

Figure 1.0: Condition of the leak prior to repair application

THE SOLUTION: Corroserv (M) Sdn Bhd proposed Bas-Rap™ (Basalt Fibre Wet Lay-Up with Corro-Dur™) system as the solution to this problem. The system was applied with minimum surface preparation to SSPC-SP 3 standard using combination of power tools cleaning method. Details of the applied system are as follow:

Surface Preparation	: SSPC-SP3 (Power Tool Cleaning)
Leak Sealing	: Mesh Tape + Corro-Dur™ 255 (min. 300 microns)
Interface	: Corro-Dur™ 563 (min. 500 microns)
Composite System	: Bas-Rap™ (1mm/layer, min. 5 layers)
Topcoat	: Corro-Dur™ 258 (min. 500 microns)

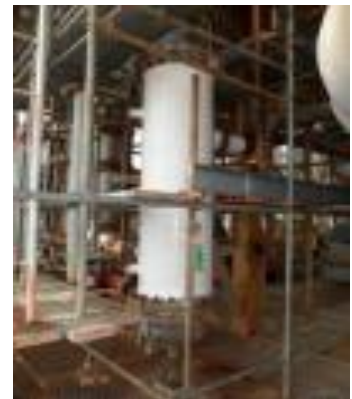
Figure 2.0: Condition of the pipe after wrapping and topcoat
