CASE HISTORY ~ CH0139

COLD WATER INTAKE PIPELINE REHABILITATION

*APPLIED SYSTEM:
LINING*

*LOCATION:
PRAI, PENANG*

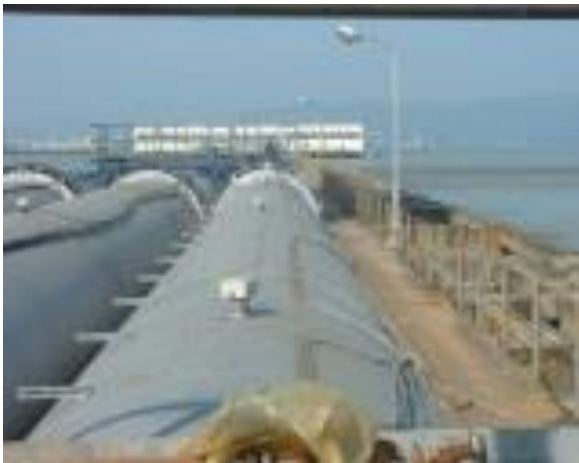
Figure 1.0: External view of the 500-meter pipeline

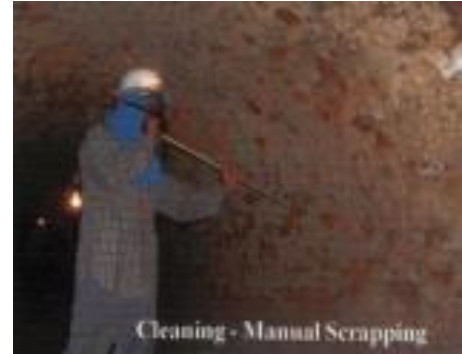
THE CHALLENGE: The internal of a 1.83m I.D., 500m length steel pipeline exhibits heavy barnacle and marine growth formation. The barnacles had penetrated the epoxy coating to attach to the substrata (steel surface), thus causing heavy and pitted corrosion. The original wall thickness of the pipe was reduced to almost 50% and replacement is inevitable.

Figure 2.0: Manual scraping of barnacles and marine growth

THE SOLUTION: The entire internal area was subjected to manual scraping/hi-pressure washing to remove thick barnacles and marine growth. Followed by abrasive air blasting to remove rust scales and other contaminants. Corro-Dur™ 561 was used to patch all pitch all pitted areas and smoothen corroded portions including weldments. Then Corro-Dur™ 258 was applied on the entire area and final coating with CeRam-Kote 99 at a total DFT of 700 to 1200 microns.

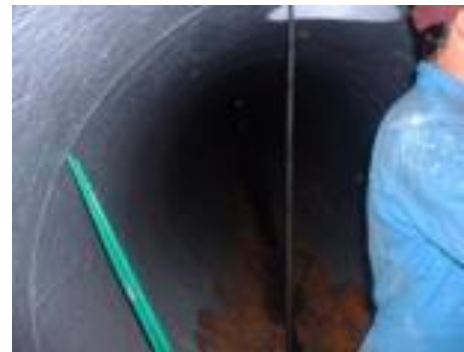
Figure 3.0: Applied Corro-Dur™ 258 over blasted surfaces

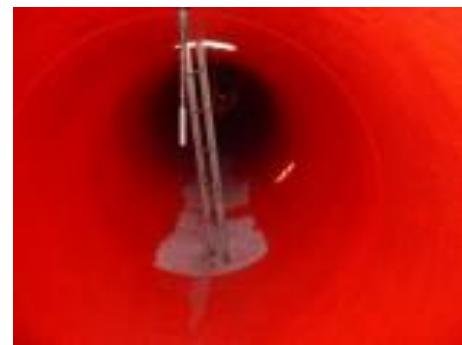
Figure 4.0: Final Topcoat using CeRam-Kote 99
