CASE HISTORY ~ CH0242

LEAK SEALING & REHABILITATION OF UNDERGROUND CLOSED DRAIN LINE (POINT 2)

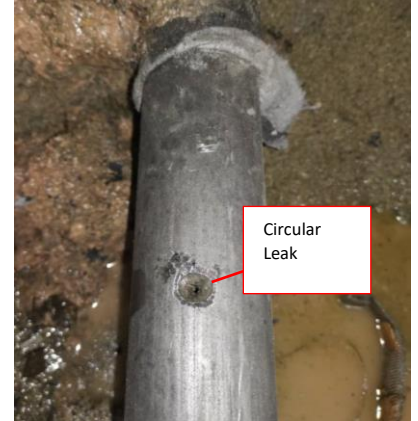
THE CHALLENGE: Currently, a circular leak defect was found on their DN50 (2") underground drain line at 2160, P5. Therefore, they need information on the available repair system that can seal the leak and rehabilitate the defect area to its design pressure and temperature. Listed below are the details of the job done:

Defect Type	: Circular Leak
Pipe OD	: DN50 (2")
Design Temperature	: 200°C
Operating Temperature	: 38°
Design Pressure	: 7 Bar
Operating Pressure	: 0.2 Bar
Medium	: Hydrocarbon (Benze, H2S & Other)

Figure 1.0: Initial condition of 2" pipe

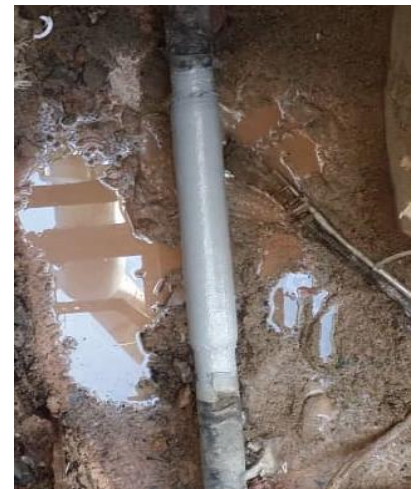
Figure 2.0: Condition of pipe after top coat application

THE SOLUTION: Corroserv (M) Sdn Bhd proposed composite wet layup system using CRBX600 saturated with Corro-Heat 206 as the composite system to solve this problem. The resin possesses high temperature and chemical resistance properties. The system was applied online with surface preparation according to SSPC-SP11 standards using non-sparking safety tools. Details of the applied system are as follow:

Surface Preparation	: SSPC-SP11 (Power Tool Cleaning to Bare Metal)
Infill & Rebuilding	: Corro-Dur™ 450
Interface	: Corro-Heat 206
Composite System	: CRBX600 + Corro-Heat 206 (0.5mm/layer) (10 layers)
Top Coat	: Corro-Heat 206
