CASE HISTORY ~ CH291

LEAK SEALING AND REHABILITATION OF 3” STEAM PIPE

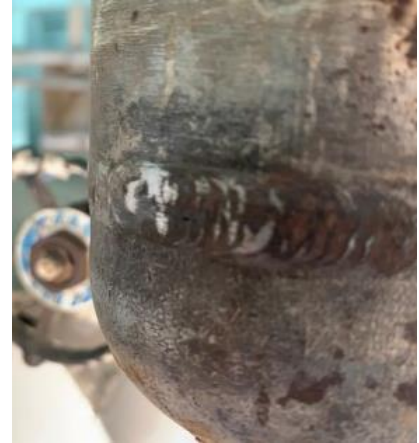
THE CHALLENGE: Previously, one of their 3” steam pipeline has failed at the weldment with crack line leak and need to be rehabilitated. Therefore, they need information on the available repair system that can rehabilitate the defect area of the pipe to its operating pressure and temperature.

Pipe Nominal Size	: 3”
Pipe Material/ Rating	: Carbon Steel, assumed SCH40
Operating Pressure	: 3.2 Bar
Operating Temperature	: 175°C
Medium	: Steam
Defect type	: Crack line leak at weldment approx. 2mm length

Figure 1.0: Defect on the pipe – crack line leak at weldment

THE SOLUTION: Corroserv (M) Sdn Bhd proposed composite Wet Lay-Up System using CRBX800 saturated with Corro-Dur™ 2000 as the composite system to solve this problem. The system was applied on surface prepared according to SSPC-SP2 standard by utilizing hand tools. Details of the applied system are as follow:

Surface Preparation	: SSPC-SP2 (Hand Tool Cleaning)
Infill/ Leak Sealing	: Hose clip lined with rubber pad
Rebuilding	: Corro-Dur™ 2000 (C)
Interface	: Corro-Dur™ 2000 (C)
Composite System	: CRBX800 + Corro-Dur 2000™ (R) (0.7mm/layer) (4 layers)
Top Coat	: Corro-Dur™ 2000 (C)

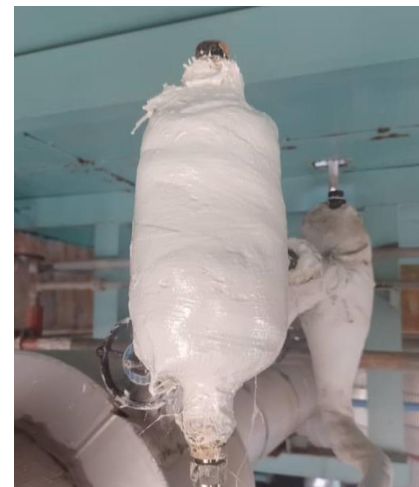
Figure 2.0: Condition of the pipe after wrapping and topcoat
