# CORROSERV (M) SDN BHD

## CASE HISTORY ~ CH247

### REHABILITATION OF 14" PRODUCTION GAS RISER (SPLASH ZONE & UNDERWATER)

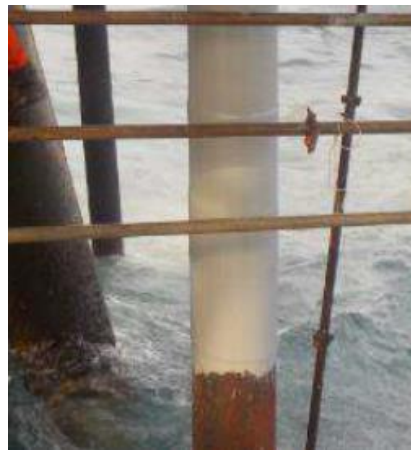
Figure 1.0: Condition of splash zone area after composite wrapping application

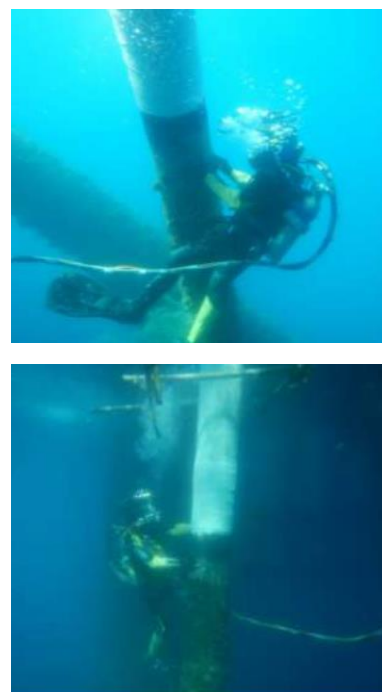
Figure 2.0: Condition of pipe after composite wrapping and top coat application.
