CASE HISTORY ~ CH0026

LEAK SEALING & REHABILITATION OF FOAM TANK EXTERNAL AREAS

APPLIED SYSTEM:
CORRO-WRAP WET LAY-UP

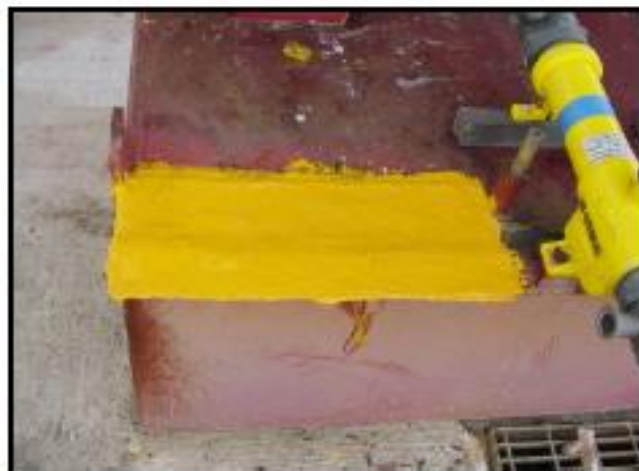
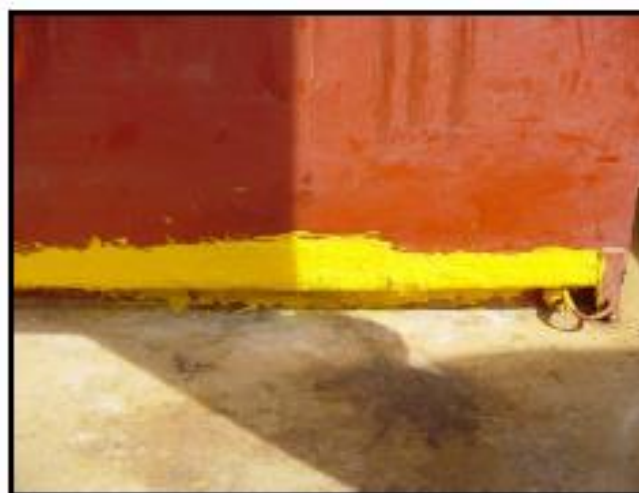
THE CHALLENGE: Currently, the foam tanks are suffering from external corrosion with leaking sections on the bottom areas. Therefore, the client needs information on the available repair system that can seal the leak and rehabilitate the defect area of the tank and provide good chemical or corrosion resistance and strong enough to resist the pressure inside.

THE SOLUTION: Corroserv (M) Sdn Bhd was asked to provide a system that extends the service life of the foam tank until the next schedule of repair or replacement. Corro Wrap Wet Lay-Up Fiberglass System was used to reinforce the wall thinning and seal the leaking area. The repair system provides a fast curing two-component epoxy to fill up the deep crevices / pitting and apply and epoxy lining to smoothen the uneven areas. Finally, the fiberglass and tissue mat saturated with Corro-Dur 561 provides chemical resistant fiberglass patching of the bottom area.
