CORROSERV (M) SDN BHD

CASE HISTORY ~ CH0032

REHABILITATION OF INTERNAL AREAS OF SEPARATOR VESSEL

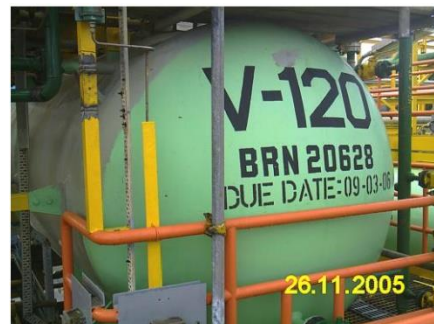
Figure 1: External View of the vessel

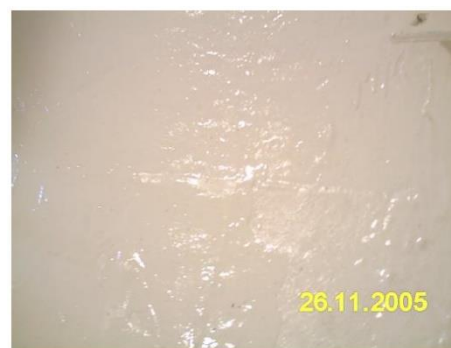
Figure 2: Close-up view of the Corro Dur Wet Lay-Up system applied in the tank

THE SOLUTION: Corroserv (M) Sdn Bhd was chosen to provide a system using Corro-Dur Wet Lay-Up fiber glass system for long term service and corrosion protection. The repair system provides a fast curing two-component epoxy to fill-up the deep pitting and apply an epoxy lining to smoothen the uneven areas. Finally, the fiberglass and tissue mat saturated with Corro-Chem 330 provides a chemical resistant fiberglass lining.

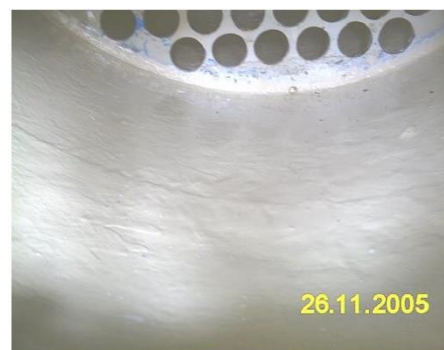
Figure 3: Compartment near the man way, fully top coated with Corro Chem 330
