# CORROSERV (M) SDN BHD

CASE HISTORY ~ CH0174

## COATING OF CARBON DISULFIDE (CS<sub>2</sub>) STORAGE TANK

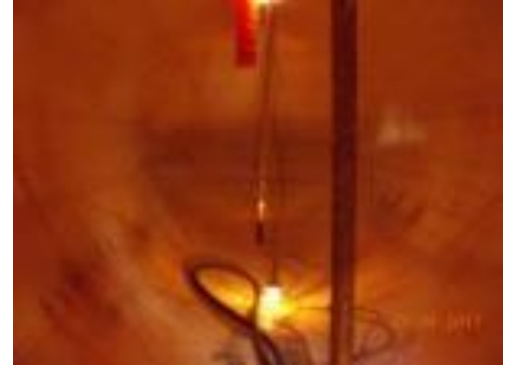
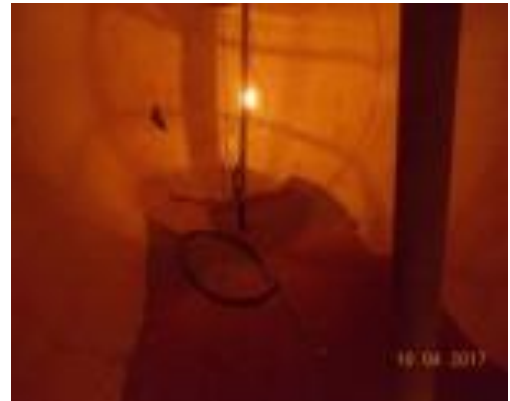
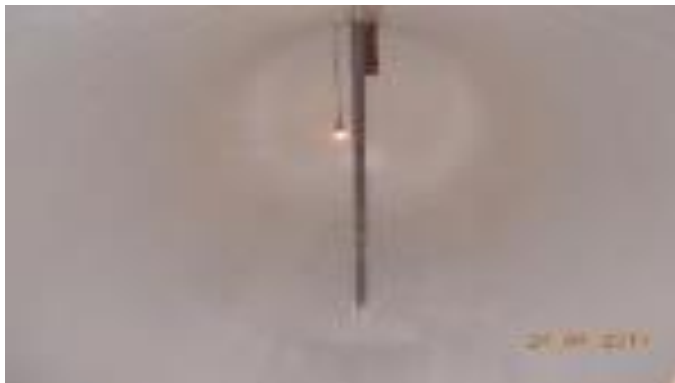
Figure 1.0: The application process for tank coating

**THE SOLUTION:** Corroserv (M) Sdn Bhd has proposed to Corro-Dur™ 255 as the solution to the needs of Client as it fulfils all their need to contain Carbon Disulfide (CS<sub>2</sub>). The system was applied upon SSPC-SP10 Dry Blasting method as the surface preparation.
