CASE HISTORY ~ CH0204

LEAK SEALING AND REHABILITATION OF 1.5” PIPE

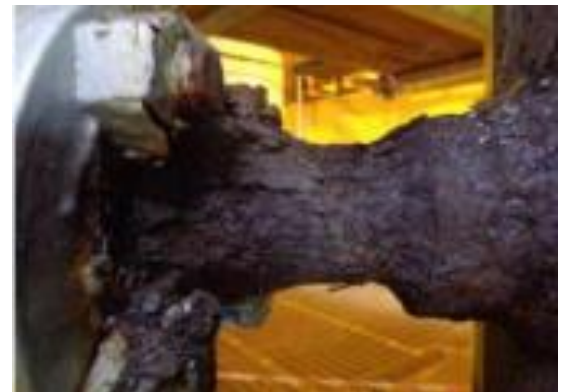
THE CHALLENGE: Currently, one of their 1.5” pipe flangeolet was severely corroded. Therefore, they need information on the available repair system that can rehabilitate the defect area of the pipe flangeolet to its design pressure and temperature.

Figure 1.0: Initial condition of 1.5” flangeolet

THE SOLUTION: Corroserv (M) Sdn Bhd proposed composite wet layup system together with our solvent free Corro-Heat 206 as the resin system to solve this problem. Corro Heat 206 has a high temperature resistance until up to 260°C, which makes it ideal for this case. The system was applied with surface preparation according to SSPC-SP1 using Bio Rust-Off and SSPC-SP11 standards using Ex-Certified Safety Tools. Details of the applied system are as follow:

Infill & Rebuilding	: Corro-Heat 206
Interface	: Corro-Heat 206 at average thickness of 500µ
Saturating Resin	: Corro-Heat 206
Composite System	: CRBX 650 (0.55mm/layer, 10 layers)
Top Coat	: Corro-Heat 206 at average thickness of 400µ

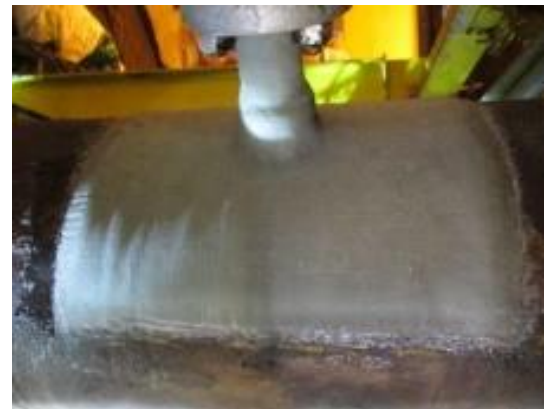
Figure 2.0: Visual of applied repair system on the 1.5” flangeolet prior to topcoat application
