CASE HISTORY ~ CH0267

LEAK SEALING AND REHABILITATION OF 8” WATER PIPELINE

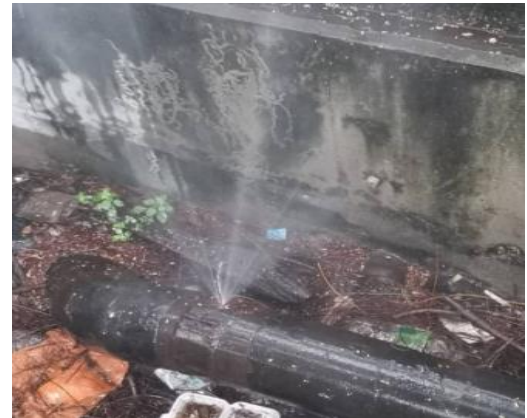
THE CHALLENGE: Previously, their one 8” water pipeline was leak on the weldment joint. They decided to stop the line and inviting us to solve their problem. Therefore, they need information on the available repair system that can seal the leak and rehabilitate the defect area of the pipe to its operating pressure and temperature. Based on the job done, the repair parameter is as listed below:

Pipe OD	: 8”
Operating Temperature	: 35°C
Operating Pressure	: 15 Bar
Medium	: Water
Defect type	: 5mm Hole

Figure 1.0: Condition of initial defect

THE SOLUTION: Corroserv (M) Sdn Bhd proposed composite wet lay-up system using CRBX600 saturated with Corro-Dur™ 192L as the composite system to solve this problem. The formulation is solvent-free to avoid the objectionable odour and explosion hazards of epoxy solvents. The system was applied online with surface preparation according to SSPC-SP3 standard by power tools cleaning. Details of the applied system are as follow:

Surface Preparation	: SSPC-SP3 (Power Tool Cleaning)
Infill & Rebuilding	: Corro-Dur™ 563
Interface	: Corro-Dur™ 563
Composite System	: CRBX600 + Corro-Dur™ 192L (0.5mm/layer) - 8 layers (4mm)
Top Coat	: Corro-Dur™ 290

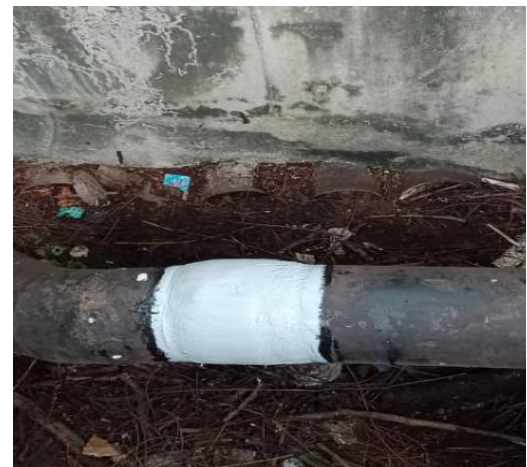
Figure 2.0: Condition of pipe after composite wrapping and top coat application
