CASE HISTORY ~ CH0061

## INTERNAL COATING OF VESSEL (FREE WATER/ GAS KNOCK OUT)

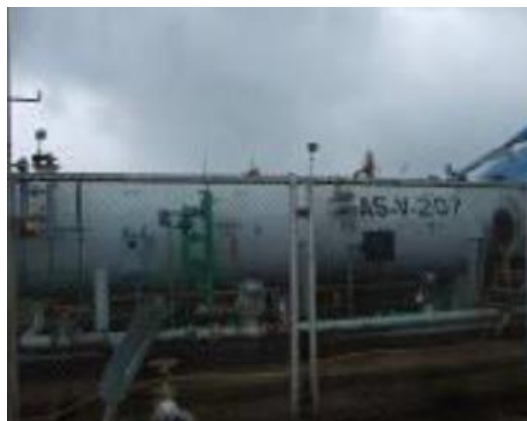
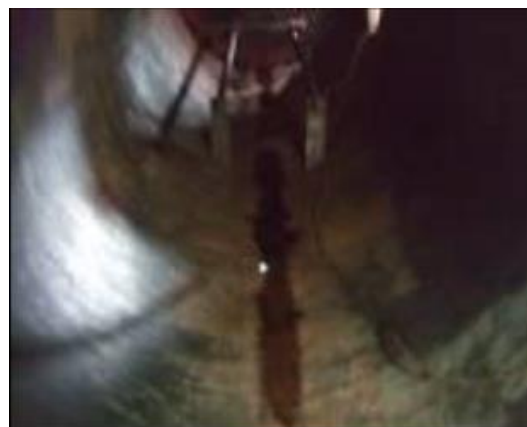
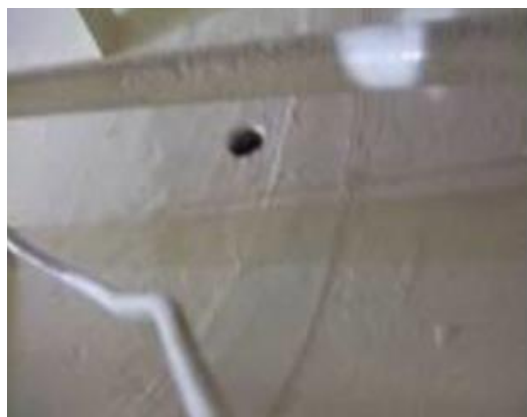
**THE CHALLENGE:** Currently, one of client's vessels has experienced coating and lining failures due to severe corrosion. The internal of the vessel bottom is badly corroded and pitted at unmeasured depth. The internal of the vessel is categorized as confined space area. There were two pieces of additional pressure perforated plate that need to be recoated.

**THE SOLUTION:** Corroserv (M) Sdn Bhd has proposed the Corro Chem 330, Bas-Rap (basalt fiber wet lay-up with Corro Dur 192L) system as solution to their requirement. The defect was patched with Basalt wet lay-up and the welding joint was lined with CRQX wet lay-up. Corro Chem 330 was applied as primer and topcoat on the entire repair area. The resin system employed for the saturation of the fiber (Corro Dur 192L) and the topcoat Corro Chem 330 are all 100% volume solids system and tolerant of moisture during application, they also have a liner curing cycle thus providing optimum adhesion and strength.

**THE RESULT:** The proposed system was designed to reinforce the existing vessel from further corrosion and extend the service life of the vessel. The job was satisfactorily completed as proposed repair procedure complying with surface preparation and application standards set by NACE/ SSPC. The minimum required pressure for adhesion test is to exceed 500 psi. The client was satisfied with whole job and the proposed system is believed to be the best solution to their problem.
