CASE HISTORY ~ CH0201

REHABILITATION OF DEAERATING CHAMBER

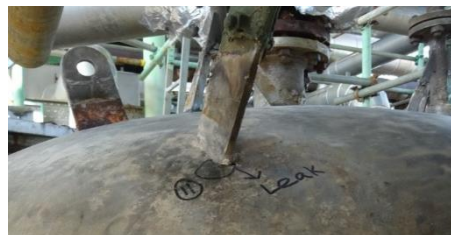
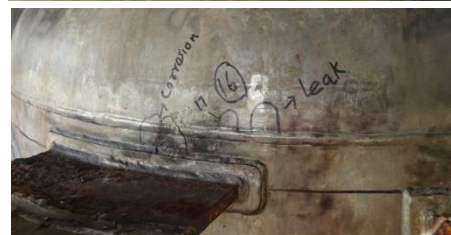
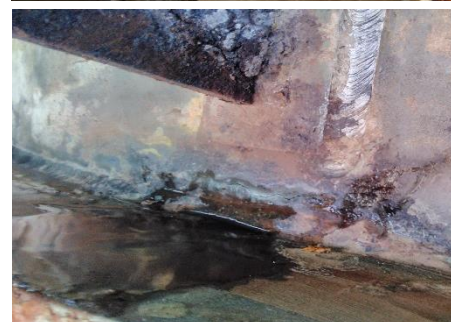
THE CHALLENGE: Currently, the Deaerator Chamber storing steam water is leaking at 2 locations which are at the top dome and weldment area of the stiffener ring. Based on the site visit report from client, the top dome has three defect points which are at the ladder lug, external lug and the circumferential weld seam. For the weldment area of stiffener ring, there are multiple cracks along the stiffener ring weldment area. Therefore, they need information on the available repair system to rehabilitate the entire vessel online to its design pressure and design temperature without a need for shut down

Figure 1.0 shows the defect point of the deaerating vessel

Surface Preparation	SSPC-SP10 (Near White Blast Cleaning) by utilizing dry abrasive blasting
Priming	Corro Chem 330 HHA (Resin)
Interface	Corro Chem 330 HHA (Resin)
Corro Wrap Wet Lay-Up	CRBX650 + Corro Chem 330 HHA
Top Coat	Corro Chem 330 HHA (Paint)

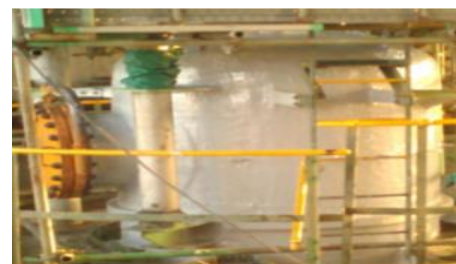
THE RESULT: The composite laminate application was applied as per the standard repair procedure. The client was satisfied with the repair system that able to seal the leak and rehabilitate the vessel to its design pressure and design temperature.

Figure 2.0 shows the condition of the deaerating vessel after application of rehabilitation system
