CASE HISTORY ~ CH0187

LKU-DS01 WELL INTEGRITY FIX REPIAR OF XMAS TREE

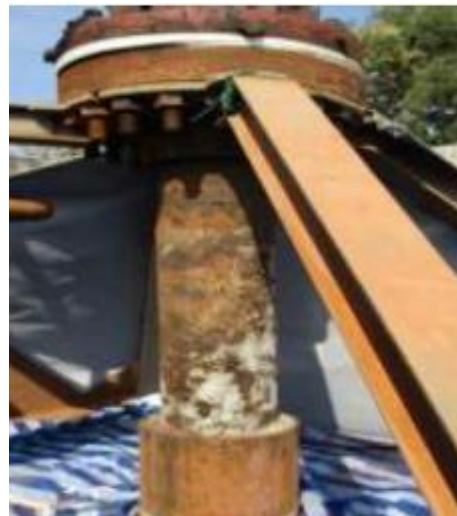
THE CHALLENGE: Client requested for rehabilitation of 9-5/8" and 13-3/8" Xmas Tree Casing which experiencing external corrosion with min thickness of 4.18 mm and a hole (30 x 50 mm) on the outer casing respectively. In addition, they found general severe corrosion with heavy corrosion scale on slot X-Mas tress surface, flange, stud bolt and nuts. Therefore, the client requested information on the available repair system which able to rehabilitate the X-Mas tress casing.

Figure 1: Image show the Xmas tree casing before wrapping application

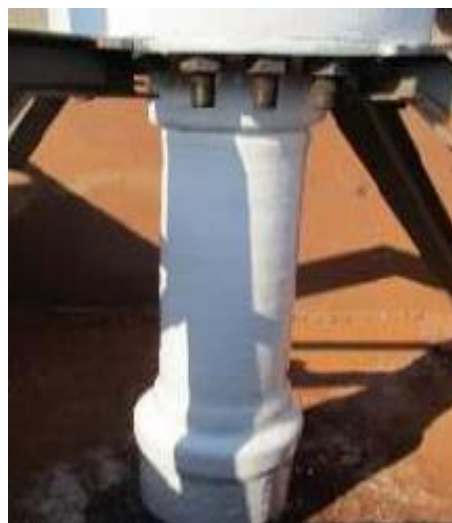
Figure 2: Image show the Xmas tree casing after wrapping application

THE SOLUTION: Wrapping system was recommended to rehabilitate the X-Mas Tree casing. The system was applied with surface preparation according to SSPC-SP11 standards using power tools cleaning to bare metal by utilizing Airtex Pneumatic grinder non-spark grinder.

Reinforce lining with CRBX

- 1) Composite system : Corro-Wrap WL (CRBX600 + CD192L) (0.5mm/layer)
- 2) Saturating resin : Corro Dur 192L
- 3) Top coat : Tower Gard 568
