CASE HISTORY ~ CH0292

ONLINE LEAK SEALING AND REHABILITATION OF 32" QUENCH WATER PIPELINE

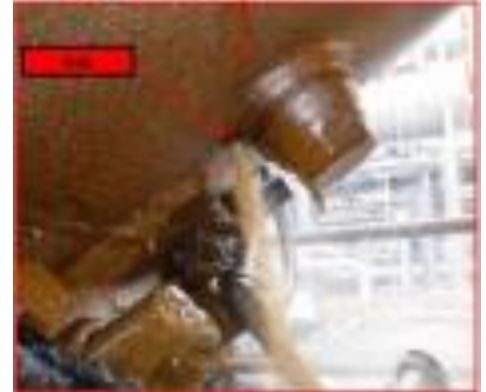
THE CHALLENGE: Previously, one of 32" quench water pipeline was damaged with pinhole leak near socket weldment and need to be repaired online. Their in-house contractor has attempted to solve the problem; however, they were unable to stop the leak. Client has then contacted and requested Corroserv (M) to propose a repair system that can be applied online to stop the leak and rehabilitate the defect area of the pipe to its design pressure and temperature.

Figure 1.0: Condition of the leak prior to repair application

THE SOLUTION: Corroserv (M) Sdn Bhd proposed composite system Corro-Wrap™ Wet Lay-Up (WL) using CRBX800 + Corro-Dur™ 2000 to solve this problem. The composite system was applied online with surface preparation according to SSPC-SP11 standard by utilizing non-sparking pneumatic tools. Details of the applied system are as follow:

Surface Preparation:	: SSPC-SP11 (power tool cleaning to bare metal)
Infill/Leak Sealing:	: Steel belt lined with CRS-8 sealant + quick seal tape
Rebuilding	: Corro-Dur™ 2000
Interface	: Corro-Dur™ 2000
Composite System	: CRBX800 + Corro-Dur™ 2000 (R) (0.7mm/layer) (23 layers)
Top Coat	: Corro-Dur™ 2000

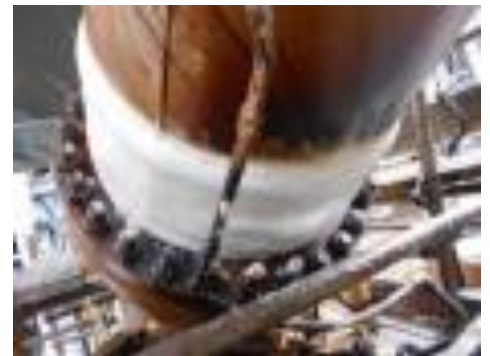
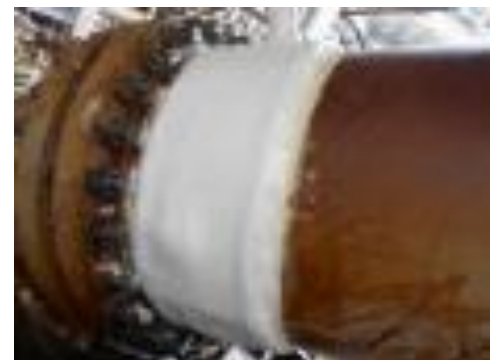
Figure 2.0: Condition of the pipe after wrapping and topcoat
