CORROSERV (M) SDN BHD

CASE HISTORY ~ CH0001

COATING OF MUD AND SLUG PITS

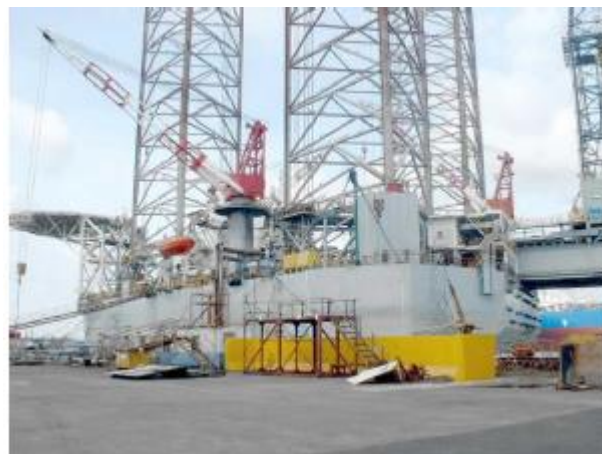
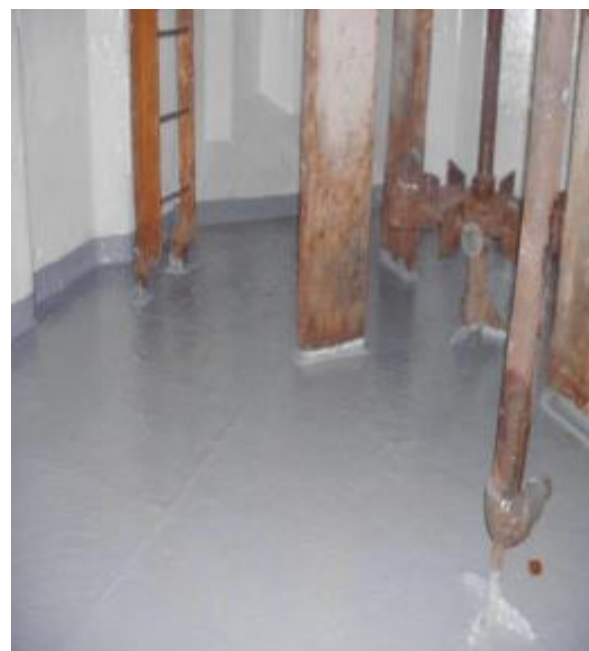
THE CHALLENGE: This jack up rig is a mobile self-elevating drilling platform equipped with legs that can be lowered to the ocean floor until a foundation is established to support the drilling platform. The walls and floors of the mud pits are heavily corroded and it needs a good protective coating for long-term protection. However, the client would not allow abrasive air blasting, instead they want an alternative method of preparation. Due to the urgency of the repair job, they also want a coating that can be applied even when there is welding in progress on adjoining areas.

THE SOLUTION: The oil rig platform undergoes extensive repairs and mud pit area were prepared by cleaning with seawater. Afterwards, all corroded and pitted area were marked for power tool cleaning using needle guns, power wire brush and grinders to remove rust scales and other contaminants. In order that the surface should have minimum soluble salt contamination such as chlorides, Chlor*Rid solutions was used to assure the client that chloride contamination was brought down to the acceptable limits of less than 5 ppm. Corro Dur 561 White and Corro Dur 258 White and Haze Gray were chosen as the ideal coating for this application.

THE RESULT: A total of 5 mud pits and a slug pit were coated with Corro Dur coatings which exhibit hard and shiny surface due to Kevlar reinforcements that contributes to a very tough coating well suited to resist mechanical abrasions during agitating process.
